TRANSPORTATION RESEARCH CENTER

ON-SITE AIR BAG INVESTIGATION

CASE NO. - 90-03
FLEET - CORPORATE VEHICLE
LOCATION - INDIANA
ACCIDENT DATE - 1990

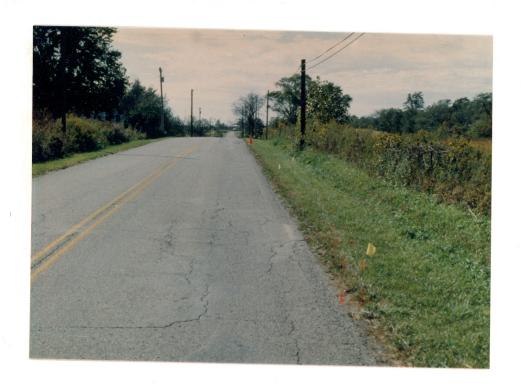
01 -- 1990
Indiana
TRC/IU: 90-03, Task: 0070
Path of travel & departure

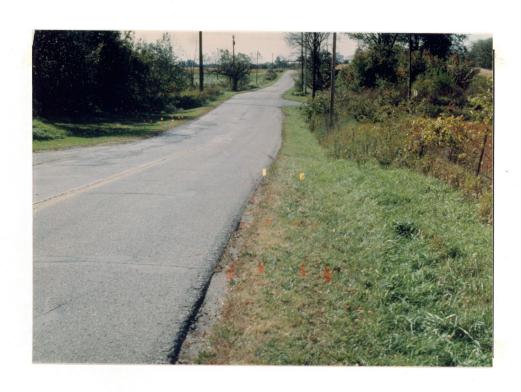
02 -- 1990
Indiana
TRC/IU: 90-03, Task: 0070
Right tire scuffs in reentry

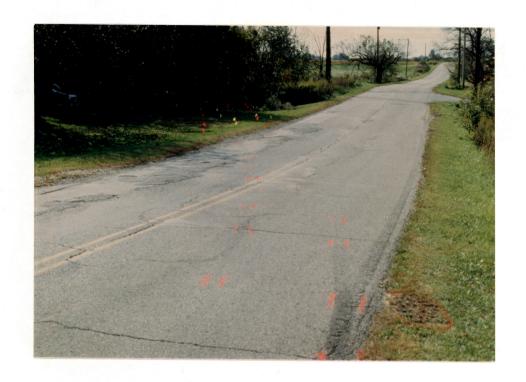
03 -- 1990 Indiana TRC/IU: 90-03, Task: 0070 Right scuffs in CCW rotation

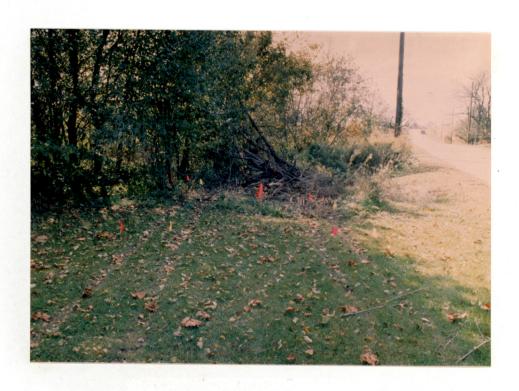
04 -- , 1990
Indiana
TRC/IU: 90-03, Task: 0070
Broadside slide into impact

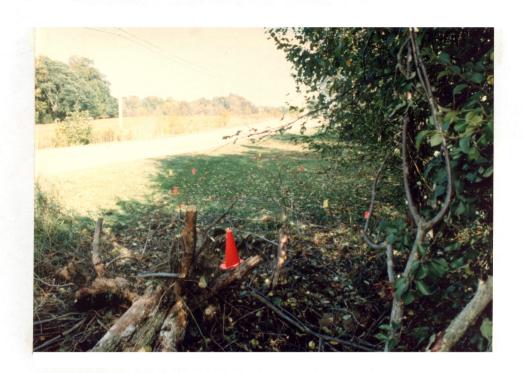
05 -- , 1990 Indiana TRC/IU: 90-03, Task: 0070 Looking back from impact

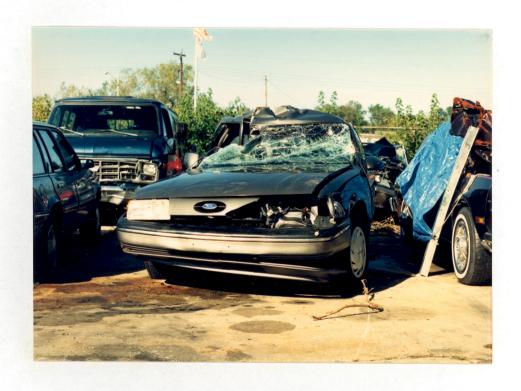
06 -- 1990
Indiana
TRC/IU: 90-03, Task: 0070
Taurus left frontal view

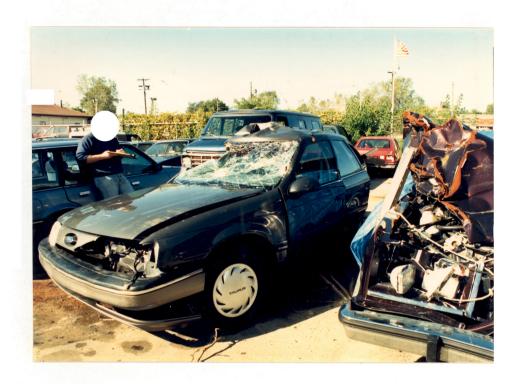
07 -- 1990
Indiana
TRC/IU: 90-03, Task: 0070
Front left leftside view

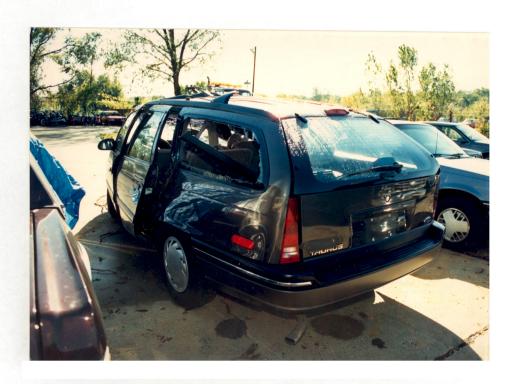
08 -- 1990 Indiana TRC/IU: 90-03, Task: 0070 Rear left rearside view

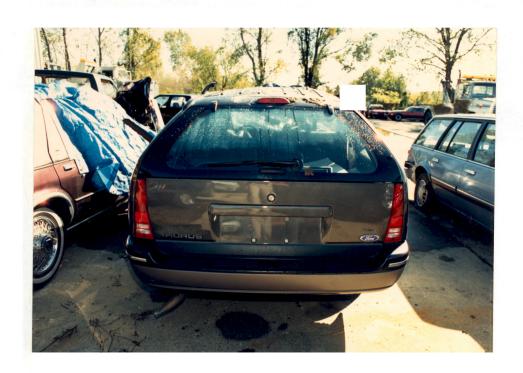
09 -- 1990
Indiana
TRC/IU: 90-03, Task: 0070
Full view of rear plane

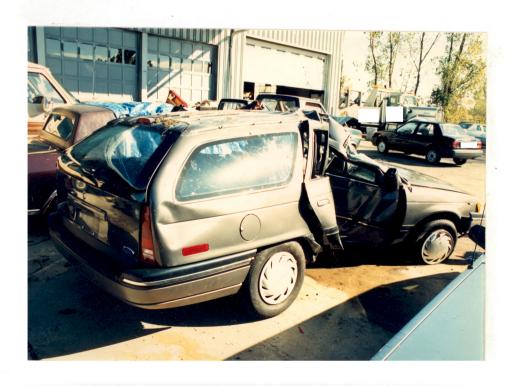
10 -- 1990 Indiana TRC/IU: 90-03, Task: 0070 Right rear rightside view

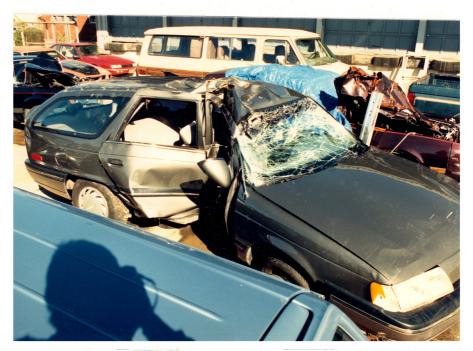
11 -- , 1990 Indiana TRC/IU: 90-03, Task: 0070 Right front rightside view

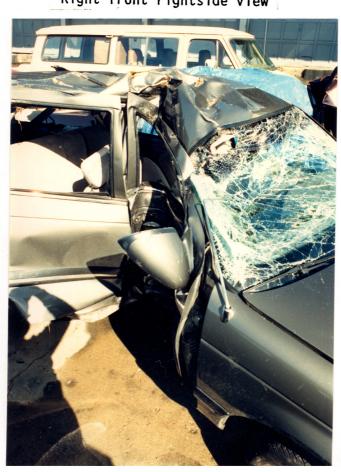
12 -- 1990

Indiana
TRC/IU: 90-03, Task: 0070
Closeup of tree impact

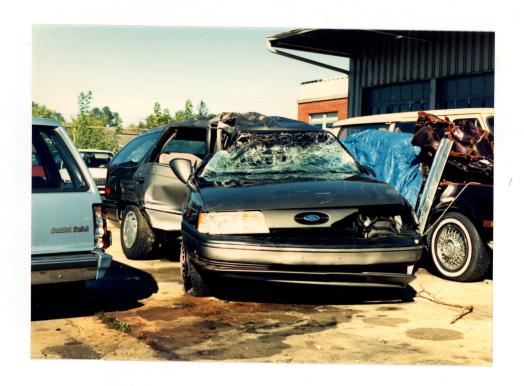
13 -- 1990 Indiana

TRC/IU: 90-03, Task: 0070 Front right frontal view

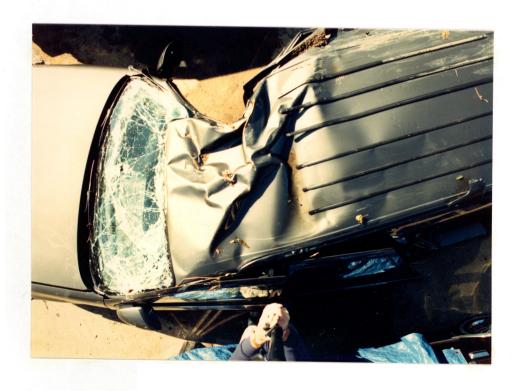
14 -- 1990 Indiana

TRC/IU: 90-03, Task: 0070 Sky view from left side

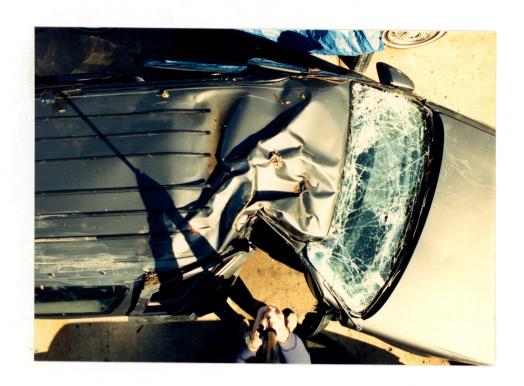
15 --1990

Indiana
TRC/IU: 90-03, Task: 0070
Sky view from right side

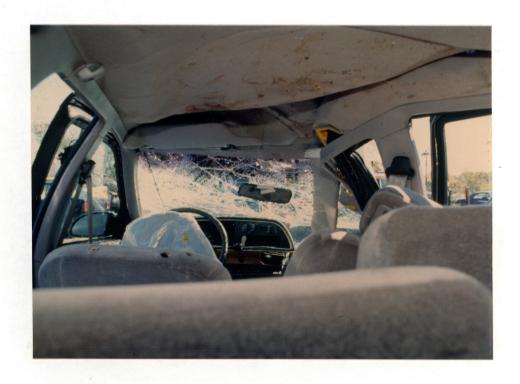
16 --1990

, Indiana TRC/IU: 90-03, Task: 0070 Interior viewed from rear
